CASE REPORT

Immediate Replacement of Extracted Tooth in the Esthetic Zone Using Resin Composite Pontic Fabricated Chairside: A Case Report

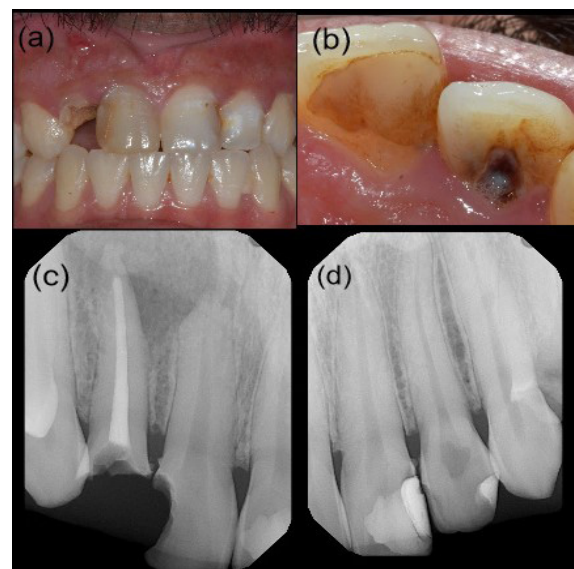
Extraoral examination was unremarkable, whereas intraoral soft tissue examination showed the opening of the sinus on the alveolar mucosa labial to the fractured tooth 12 (Figure 1a). Tooth 12 was fractured to the gingival level, and caries were still evident on the remaining tooth structure. Discolored resin composite restorations were present on teeth 11, 21, and 22 that were imparting a poor overall appearance (Figure 1a). In addition to deep palatal pit caries on tooth 22 (Figure 1b), several other carious teeth were noted in both the quadrants. Periodontal assessment showed generalized moderate periodontal disease with plaque and bleeding scores of 46% and 47%, respectively. Cold sensitivity testing was performed on teeth 11,13,21,22, and 23 using Endo-Frost (Roeko, Langenau, Germany). Teeth 13, 21, 22, and 23 reacted positively, whereas tooth 11 showed no response to the cold test. No tenderness to percussion was noted on teeth 11, 12, 21, and 22. Periapical radiographs (Figures 1c and 1d) showed inadequate endodontic treatment of tooth 21 with a large periradicular radiolucency. The previous restoration

Figure 1 (a-d): Pre-operative view showing fractured tooth 12 with associated sinus and discolored restoration on neighboring teeth (a). Deep pit caries evident on tooth 22 with discolored resin composite restoration on tooth 21 (b). Periapical radiographs of teeth 11, 12, 21, and 22 (c&d).

of tooth 11 was dislodged during the examination to reveal a large cavity near the pulp. Periradicular radiolucency and shortening of the root of tooth 11 could also be seen on the radiograph. Recurrent caries were evident on teeth 21 and 22, but no periradicular changes were noted. The prognosis of tooth 12 seemed poor, whereas teeth 11, 21, and 22 appeared to have a good prognosis if adequate restorative treatment was provided.

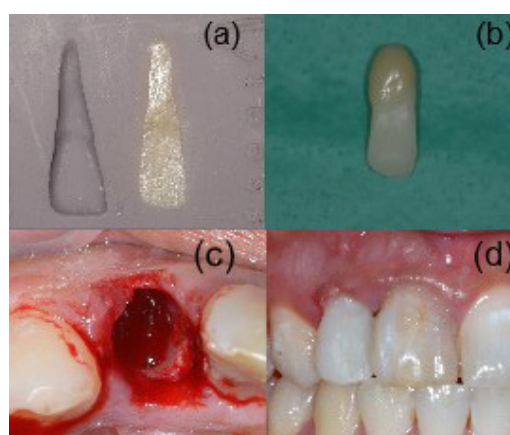
Figure 2 (a-d): Fabrication of resin composite pontic using tooth mold (a&b). View immediately after extraction of tooth 12 (c). Cementation of the pontic with adjacent teeth immediately following extraction (d).

Filtek Z250 XT (3M) universal nanohybrid resin composite shade A2 was used to fabricate a pontic using a tooth mold from the Essentia composite kit (GC, America) (Figure 2a). The pontic was trimmed using a high-speed diamond bur to create an ovate shape to fit in the extraction socket to support the soft tissues (Figure 2b). Tooth 12 was extracted atraumatically using a straight elevator and maxillary incisor forceps (Figure 2c). The approximal surfaces of teeth 11 and 13 and pontic were etched, and the adhesive was applied as described above. The pontic was placed in the extraction socket at least 2 mm below the gingival margin and bonded with teeth 11 and 13 (fixed-fixed) using Filtek™ Supreme Ultra Flowable Restorative (3M) and reinforced with Filtek Z250 XT (3M) universal nanohybrid resin composite shade A2 (Figure 2d). The fixed-fixed design was used as tooth 11 lacked enamel for bonding and to provide more rigidity to the bridge. The final finishing and polishing were performed using fine diamonds and Enhance PoGo (Dentsply Sirona) polishing system. A 0.2% chlorhexidine mouthwash Corsodyl (GSK, UK) was prescribed to be used three times a day for a week.

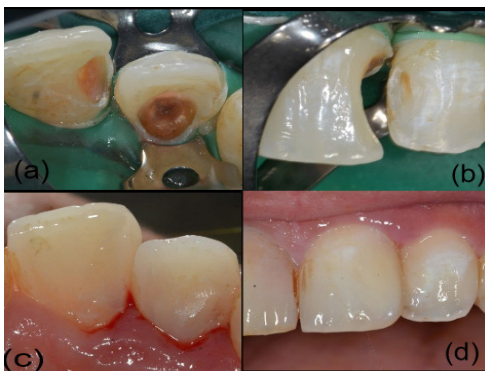
Figure 3 (a-d): Palatal view of cavities preparation in teeth 21 and 22 (a). Labial view of cavities preparation in teeth 21 and 22 (b). Palatal and labial views of completed resin composite restoration in teeth 21 and 22 (c&d).

On subsequent visits, restoration of teeth 21 and 22 was completed as shown in Figures (3 a-d). After the completion of the endodontic treatment of tooth 11, the pontic 12 was removed and its

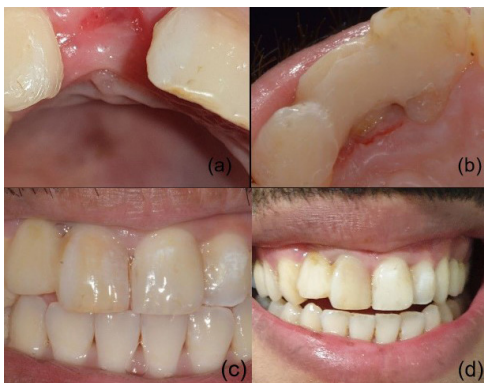
Figure 4 (a-d): Removal of pontic 12 after two months of healing (a), re-cementation of pontic 12 using SUPER-SPLINT (a&b). Postoperative view after three months of treatment (c). Postoperative view after 10 months of treatment (d).

tissue surface was adjusted to match the soft tissue profile of the healing extraction socket (Figure 4a). The pontic was then again splinted to the abutment teeth using Filtek Z250 (3M) resin composite shade A2 reinforced with SUPER-SPLINT (Hager & Werken GmbH & Co., Duisburg, Germany) glass fiber tape (Figure 4b). The fiber-reinforced bridge was left in situ as long-term provisional restoration until the oral hygiene was stabilized and the patient decided for a more definitive replacement option. The patient was recalled after 3 and 10 months of final splinting of pontic 12 as shown in Figures 4c&d. Oral hygiene instructions were the mainstay of the treatment phase and were reinforced at every treatment visit with particular emphasis on the use of Oral-B super floss (Procter & Gamble, Cincinnati, USA) under pontic area 12. Similarly, periodontal debridement and restoration of carious teeth were part of the stabilization phase of the treatment.

surface adjusted, and it was rebonded with fiber reinforcement as long-term provisional restoration on the patient's request. The patient was reviewed after 3 and 10 months. He had well-maintained oral hygiene, and no complications were noted.
